Manhole Inspection Summary

Manhole # S25C__003MH

Location Address: **318 CARROLLTON AVE**

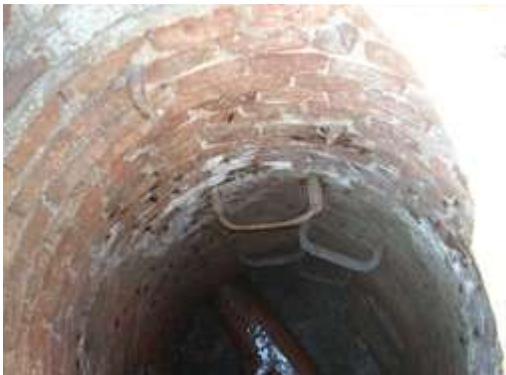
Defect 3

Count: **3** Missing: **2** ☒ **Corroded**

CORRODED STEPS

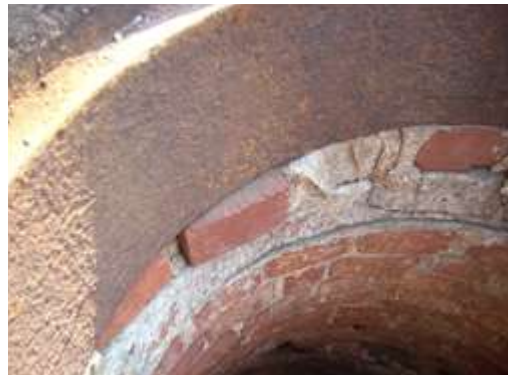
Defect 2

Condition: ☐ Sound ☐ Cracked ☐ Root Intrusion ☒ **Loose Brick** ☐ Deteriorated

LOOSE BRICKS IN CHIMNEY

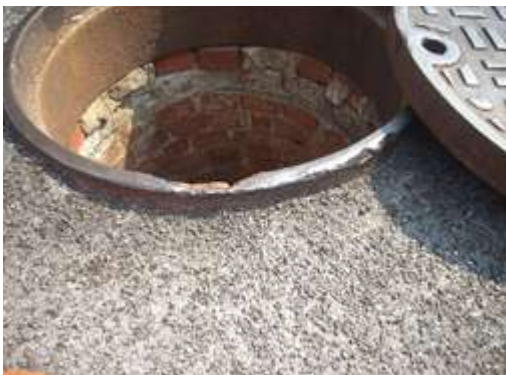
Defect 1

GRADE ADJUSTMENT WITH A WORN FRAME

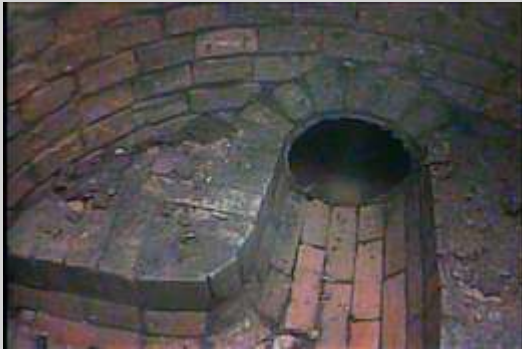
12 O'Clock Outflow

Pipe Height: **10.8** (in.) Rod and Bar (Angled)
Pipe Material: **Clay** ☐ Pipe Lined
Invert Depth: **10.55** (ft.) Flow Characteristics: **Slow**
Deposits: ☒ None ☐ Mud ☐ Sludge ☐ Debris ☐ Grease
Silt Depth: (in.) Deposits Extent:
Infiltration: **None** Pipe Seal Cond: **Sound**

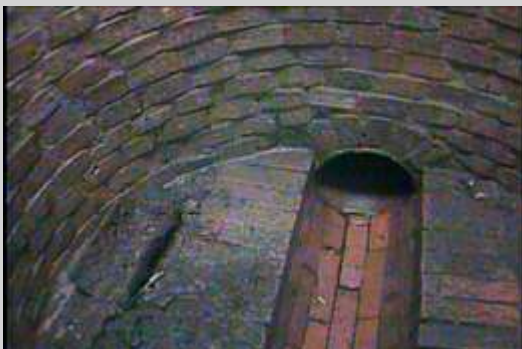
6 O'Clock Inflow

Pipe Height: **9.6** (in.) Rod and Bar (Angled)
Pipe Material: **Clay** ☐ Pipe Lined
Invert Depth: **10.25** (ft.) Flow Characteristics: **None**
Deposits: ☒ None ☐ Mud ☐ Sludge ☐ Debris ☐ Grease
Silt Depth: (in.) Deposits Extent:
Infiltration: **None** Pipe Seal Cond: **Sound**

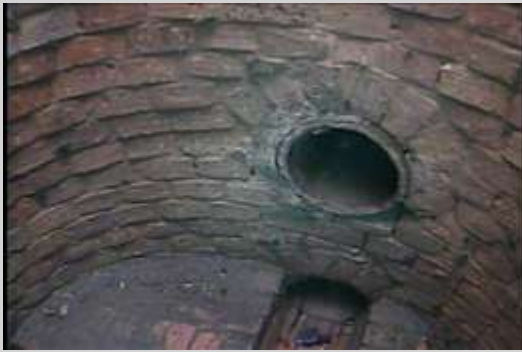
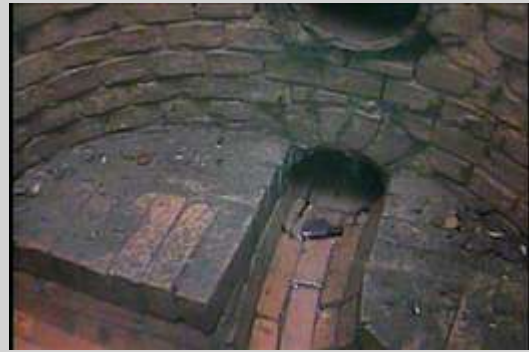
9 O'Clock Inflow

Pipe Height: **7.2** (in.) Rod and Bar (Angled)

Drop: **Outside** Rod and Bar

Drop Condition: **Open**
